West Gate Bridge Strengthening Project

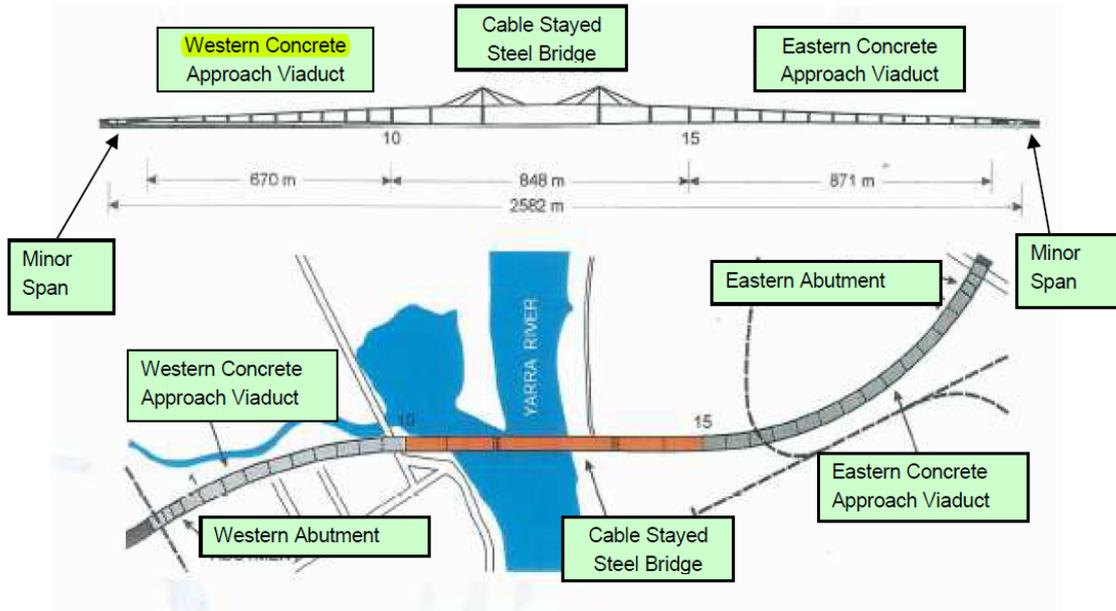
Fig 1 - Arrangement

The West Gate Bridge is 2.5km long and is made up of three different structural types:

- a) composite steel beam and concrete deck approach spans;
- b) pre-stressed concrete box girder viaducts, and;
- c) Central, cable-stayed steel box girder with orthotropic steel deck section.

Figs 1 and 2 below show the general arrangement of the bridge and a typical cross-section prior to the strengthening project.

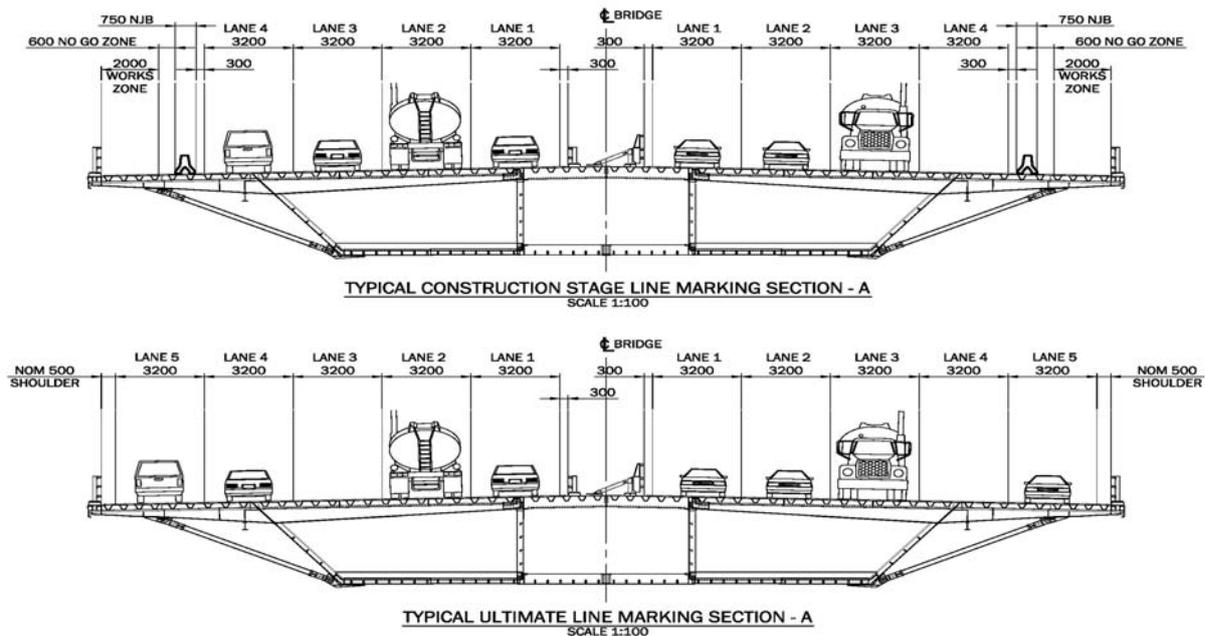
Fig 3 – Bridge cross-section

Resulting reports recommended the conversion of the existing 2.5m wide emergency stopping lane and standardization of lane widths across the bridge at 3.2m to provide a 5th lane in each direction. The final roadway cross section is shown in fig 3 below.

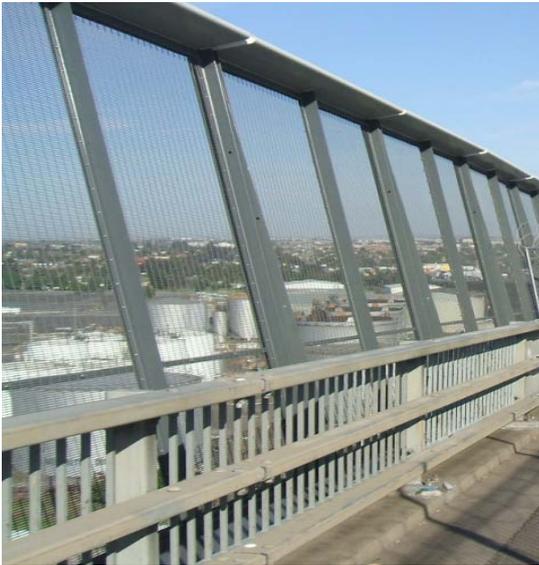
Fig. 4. Public Safety Barrier

Public safety barriers (PSBs) were installed along the length of the bridge (fig 4). The PSB's posts were aligned with barrier posts and connected to end of cantilevers with a bolted bracket connection on both the steel and the concrete bridges.

All of the bridge expansion and contraction is taken at the junction between the steel and concrete bridges at Piers 10 and 15. A special detail was developed at the bridge expansion joint to accommodate these very large bridge movements. It comprises two interconnected cantilevered panels that slide past each other.

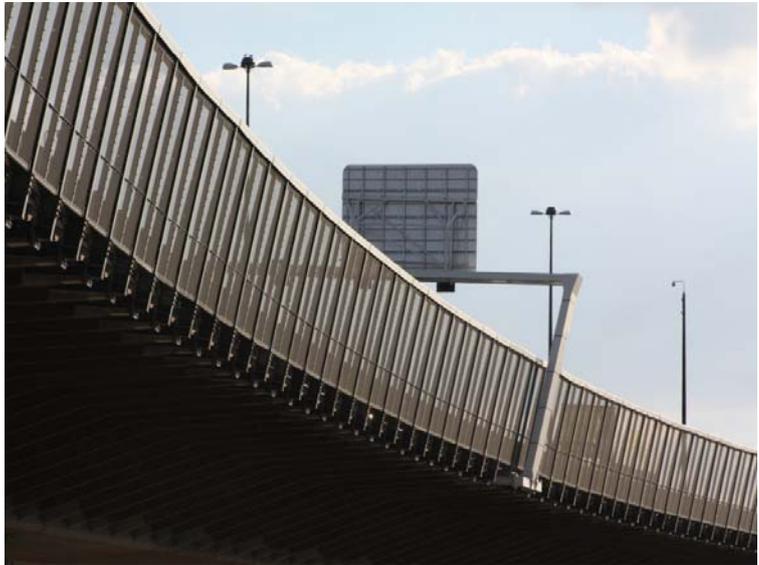
Fig. 5. FMS gantry

Being part of the section of freeway covered by the M1 Freeway Management System (FMS), four gantries (fig 5) were required on the bridge viaduct, as well as gantries just off the bridge, for mounting variable Lane Use Management Signs. Arriving at a concept for the gantries and accommodation of the loads they applied to a structure not designed originally for such loads presented both a design and constructability challenge.

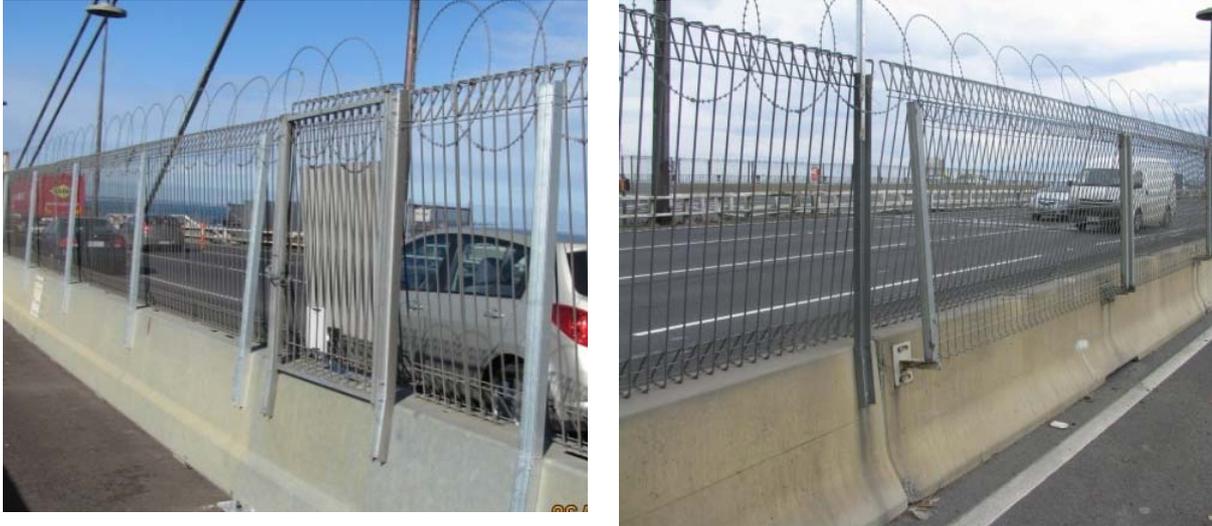
The bridge had been operated since its opening with four traffic lanes and an emergency lane in each direction. A basic requirement of the project was for the bridge to be strengthened to allow the emergency lane to be used as a full traffic lane thereby providing five traffic lanes in each direction with no emergency lane. To provide access to the external areas of the bridge, the emergency lane was converted into the "construction lane" with the addition of temporary steel and concrete New Jersey Barriers along the full length of the bridge in each direction. These barriers separated the site from the flowing traffic and allowed work to be executed at any time of the day (or night) without lane closures. To further delineate the site and to reduce the risk of suicide attempts, it was decided to provide full fencing along the top of the barriers.

Fig. 6. Temporary steel (left) and concrete barriers (right) separating the construction lane

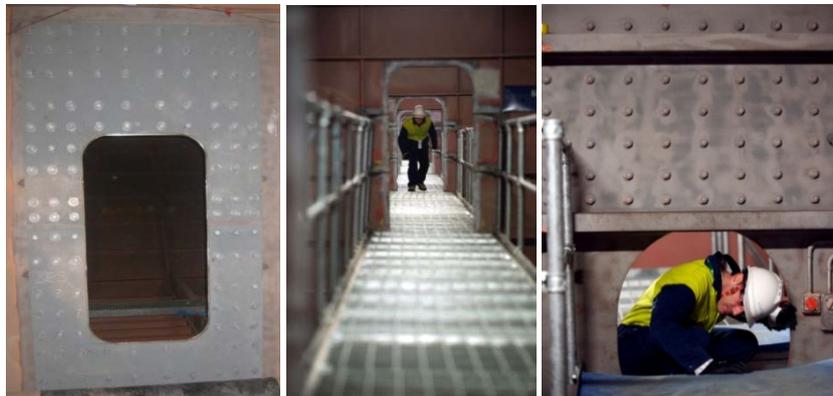
Improvement of internal access through the steel bridge was one of the first tasks undertaken. New walkways were installed in the bridge to allow workers to traverse the entire length of the bridge above all the transverse stiffeners. To facilitate passage through diaphragms and inner webs, the existing manholes were enlarged at the diaphragms and new larger openings provided through the inner webs at specific locations. The only exceptions to this improvement in internal access were the openings in the diaphragms over the piers. Because of the critical role these four diaphragms play in the support of the bridge, there was no practical way of enlarging these openings.

Fig. 7. Enlarged inner web manholes (left), diaphragm manholes and new walkway (middle) and diaphragm opening at piers (right).

The original median deck openings were also enlarged to allow larger sized materials to be delivered into the bridge.

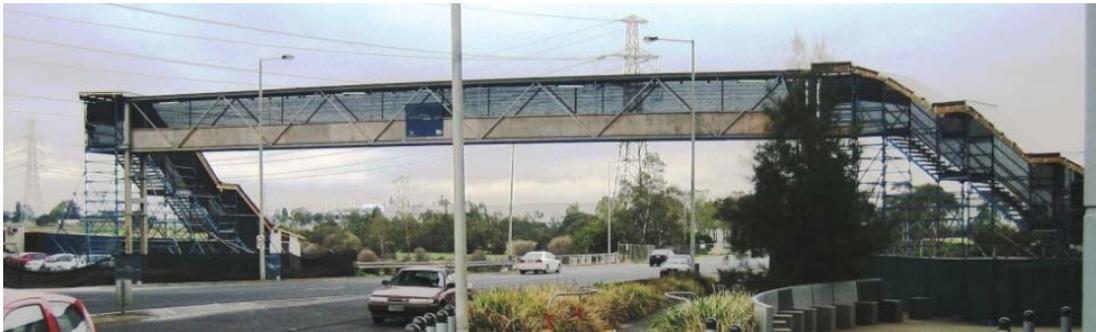
ground level messing facilities and the Alimak hoist. To provide safe access for personnel, a footbridge was constructed using a 33 metre long modified sign gantry for the main span, along with scaffolding to provide stair access at each of its ends.

Fig. 8. Temporary Pier 10 (Hyde Street) Footbridge.

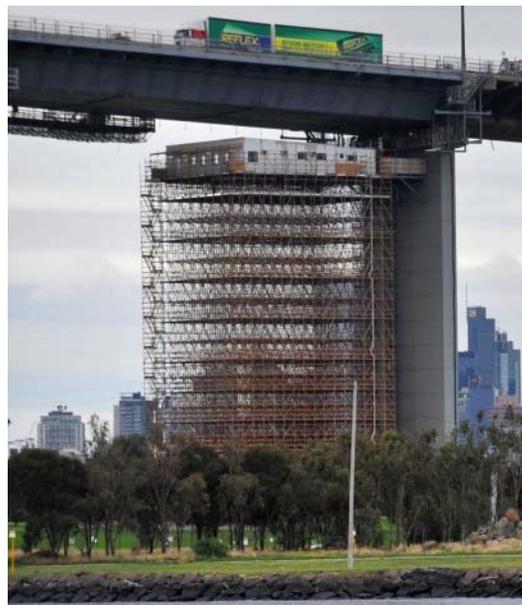
To minimise downtime for the teams working inside the bridge, particularly the time taken for meal breaks, the project undertook its single largest temporary facility provision by constructing messing and change facilities on birdcage scaffolds just below the soffit of the steel bridge. Two of these facilities were constructed, one at Pier 10 and one at Pier 15, each 45m above ground level, each with messing, changing and toilet facilities for 100 people.

Fig. 9. Temporary Messing Facilities at Pier 15.

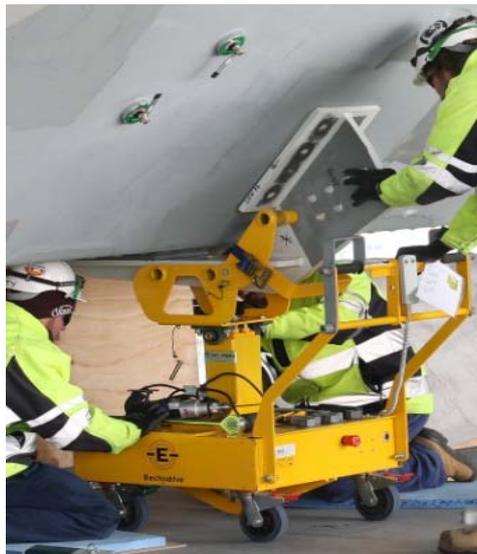
Custom-designed mobile hydraulic lifting tugs were installed on the platforms suspended under the bridge to lift the bottom steel bracket for the new cantilever props into position for fixing to the bottom flange of the bridge. This lifting tug was highly effective and minimised the manual handling required for the works. For the top steel bracket for the cantilever props a proprietary mobile, manually operated, forklift was modified for lifting the 60kg piece 3 metres up on to the bridge cantilever beam.

Fig. 10. Mobile hydraulic lifting tug lifting a bottom steel bracket into position

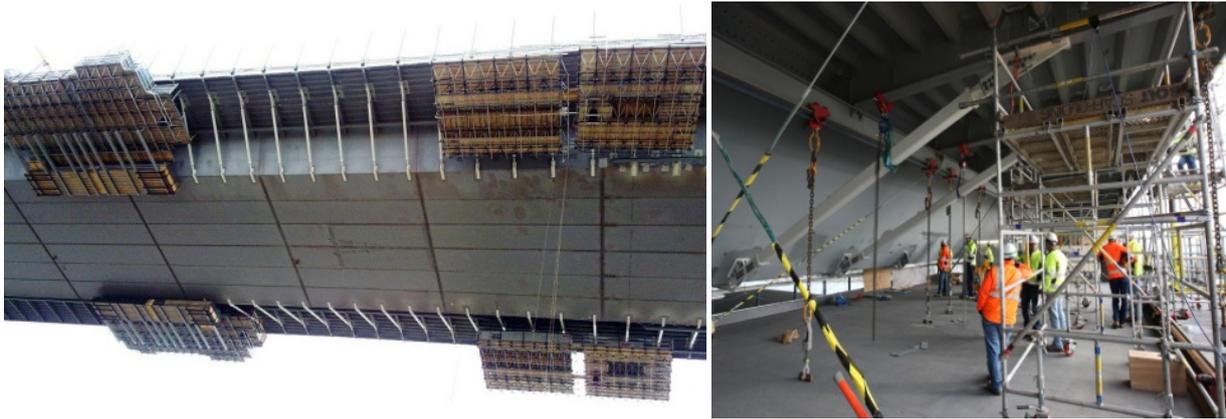
Fig. 11. View looking up at APS platforms (left). Work being undertaken on platform (right).

The platforms were suspended on chains from the cantilever beams of the bridge (concrete and steel). The chains were connected to runway beams mounted on the platform. When the platform were required to be moved, new chains were preinstalled ahead of the platform and then existing chains were unlocked to allow the platform was winched forward. Once the platform reached the new position, the new chains were locked and the platform braced and then work could recommence.

- Generator, potable water, toilets and sewage tank
- Messing facilities with office
- Davit crane for lifting equipment from the construction lane onto the platform
- Storage areas for all permanent and temporary equipment
- Deck area to allow the lifting tug and manual forklift to operate
- Solid work deck to ensure complete encapsulation during wet and dry blasting

With all these facilities, the work crew could remain on the platform for the whole shift which lead to a very efficient operation. At the peak of production there were 16 platforms, of various configurations, providing 7,000 square metres of access.

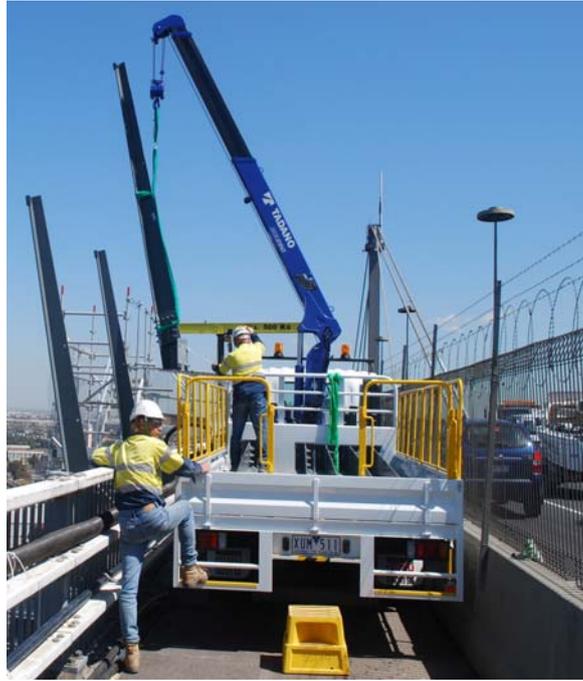
The solution devised was to use a small truck with a relatively large (10 tonne metre) hydraulic crane and winch. As such a vehicle is rare, and there were none readily available, the project opted to purchase the vehicle and the crane and have them customised to suit project requirements. Once delivered, this vehicle was so versatile that it was used around the clock on many more activities than had been originally planned.

Fig. 12. Crane Truck in use in the Construction Lane
